PRESERVATION GUIDE FOR  
STONE MASONRY  
AND DRY-LAID RESOURCES

ABBY GLANVILLE

GREG HARTELL INTERN  
FOR HISTORIC PRESERVATION

SUMMER 2008

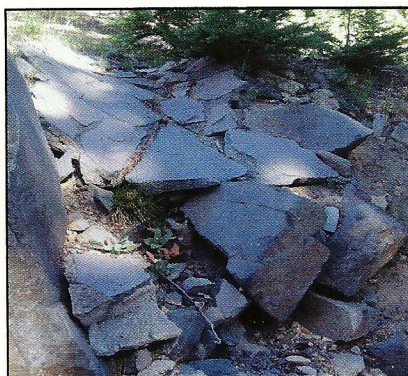
Deterioration of a tiled masonry drain across from the Sun Notch parking lot at mile 4.4

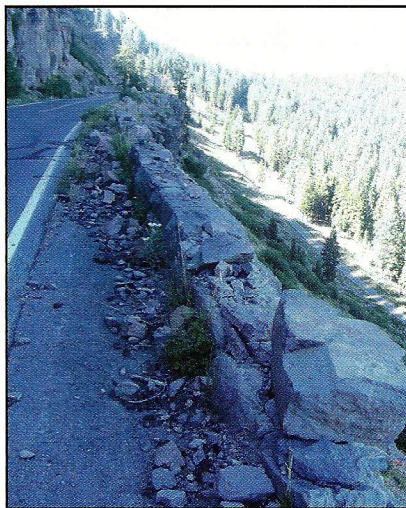
Massive deterioration of guard wall along Dutton Cliff at mile 7.5-8.0

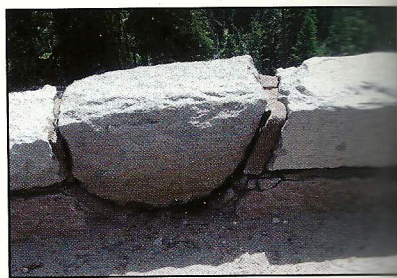
Guard wall at mile 4.5-5.0 on Sun Grade showing a loose stone caused by mortar deterioration.

Mortar should be removed to a depth of 2 to 2 ½ times the width of the joint. For exceptionally wide joints mortar may have to be removed to a depth of several inches.<sup>12</sup> Any loose or disintegrated mortar

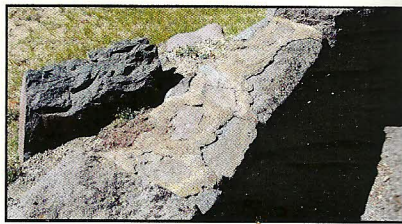
Proper mortar application and stone selection are of utmost importance to retaining the historic appearance of these guard walls. The following photograph shows the result of incompatible repair to a section of a guard wall. Notice that several small rocks were pieced together to fill space rather than stones of the recommended dimensions in the stone selection guidelines. In addition, the mortar joints are too wide and were not raked out to the specified depth. The mortar application in this section is quite sloppy and appears unfinished in comparison to the rest of the wall. Furthermore, because the joints were not raked the stones become less signifi-

cant than the mortar which ultimately gives the wall a less natural appearance.

Guard wall at Sentinel Point (mile 10.7), showing incompatible repair.

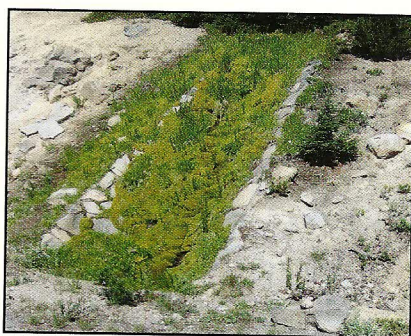
only slows water flow, but also increases the accumulation of rocks and debris that can clog the culverts they direct water into. Furthermore, the roots of weeds and shrubs growing through deteriorated mortar can damage the stones and open pathways for moisture to penetrate.<sup>20</sup> Mosses and lichens also retain moisture that erode stone and mortar.

Moss covered spillway at mile 5.0.

Chemicals should not be used to control plant growth as they can damage the mortar and stone and also pollute water. Damaged stones should be replaced and mortar repointed on these features where necessary.

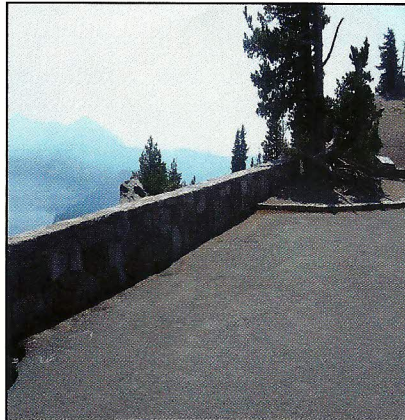
The guard wall at the turnout at mile 24.0 was constructed without merlons at regularly spaced intervals even though the view behind the wall is unobstructed.

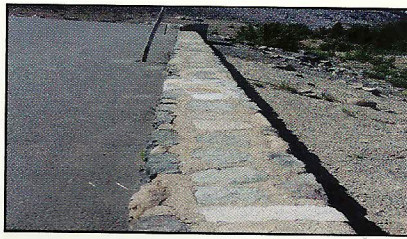
The guard wall at the turnout at mile 25.2 forms a rigid, straight line that contrasts with the surrounding terrain. Also notice that the mortar joint were not raked and the stones are not of the specified size.

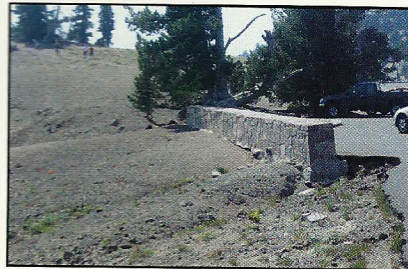
This wall demonstrates incompatible stone work with the use of shaped stones with cut faces exposed. The absence of rough-faced stones and the bunching of small, more uniformly sized stones creates an unnatural appearance.

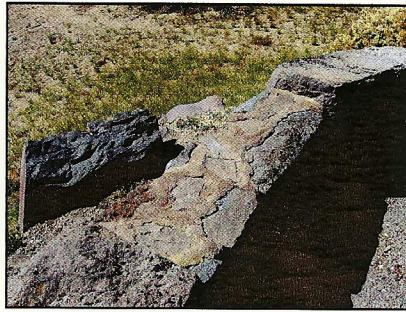
This wall section shows incompatible mortar application. The joints are not raked back allowing the mortar to become more significant than the stones.

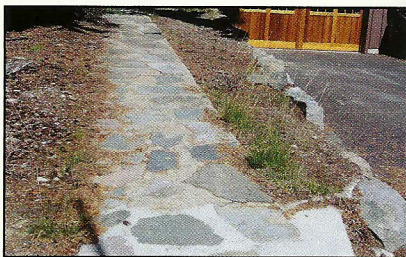
The stone walkway at the Superintendent's Residence (Science and Learning Center) demonstrates inappropriate mortar application and joints that are not properly raked.

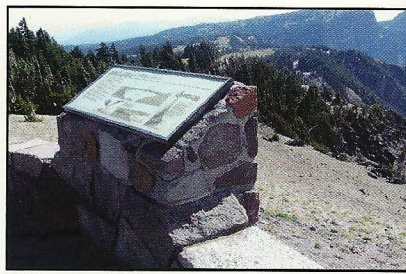
Addition of the monument to the top of the merlon was done using stones of incompatible size and color.
